## BMR Microbiology

### *Review Article*

# Role of Cyanobacteria In Biodeterioration of Historical Monuments -A Review

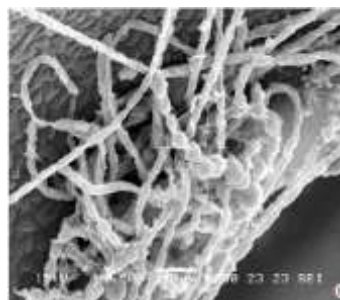
*Westiellopsis prolific* Janet X500
